POSTIRRADIATION EXAMINATION OF THE
PM-3A TYPE 1 SERIAL 2 CORE
PART I. POSTIRRADIATION EXAMINATION
OF FUEL TUBES

February 28, 1967

John B. Brown, Victor W. Storhok, and John E. Gates

BATTELLE MEMORIAL INSTITUTE
Columbus Laboratories
505 King Avenue
Columbus, Ohio 43201

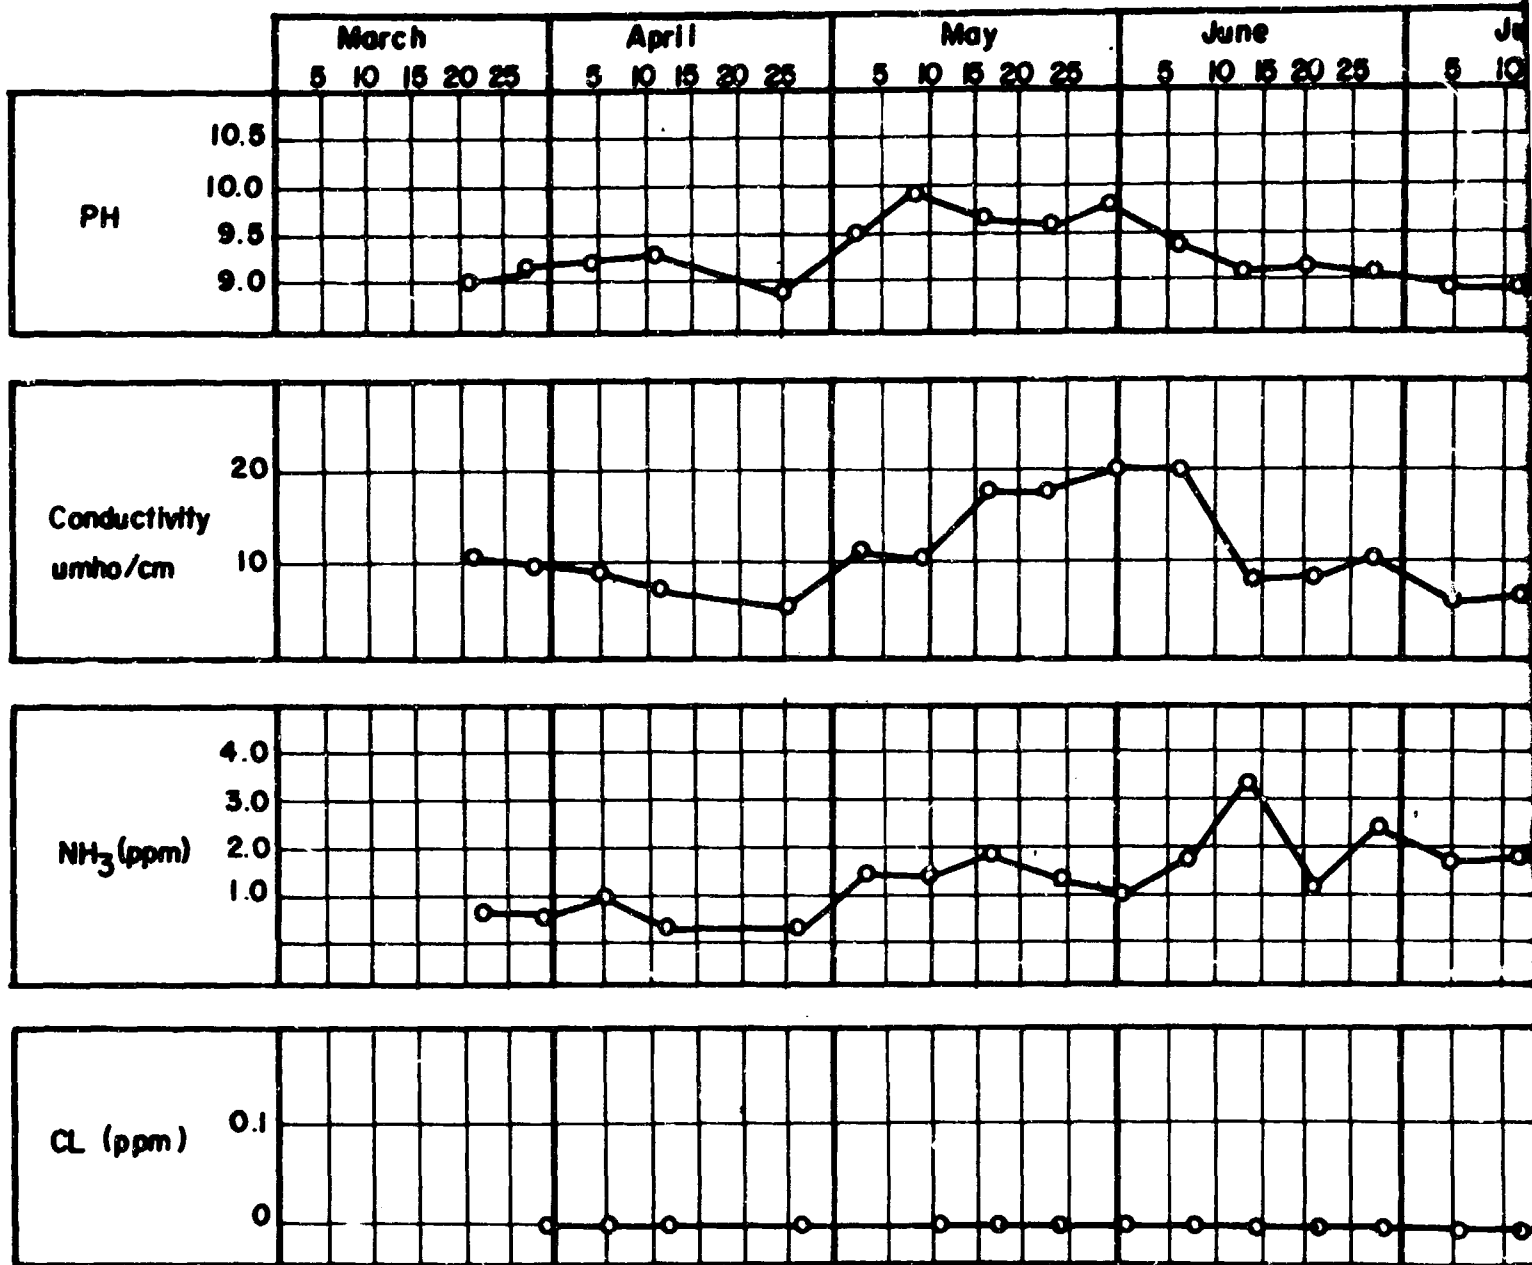
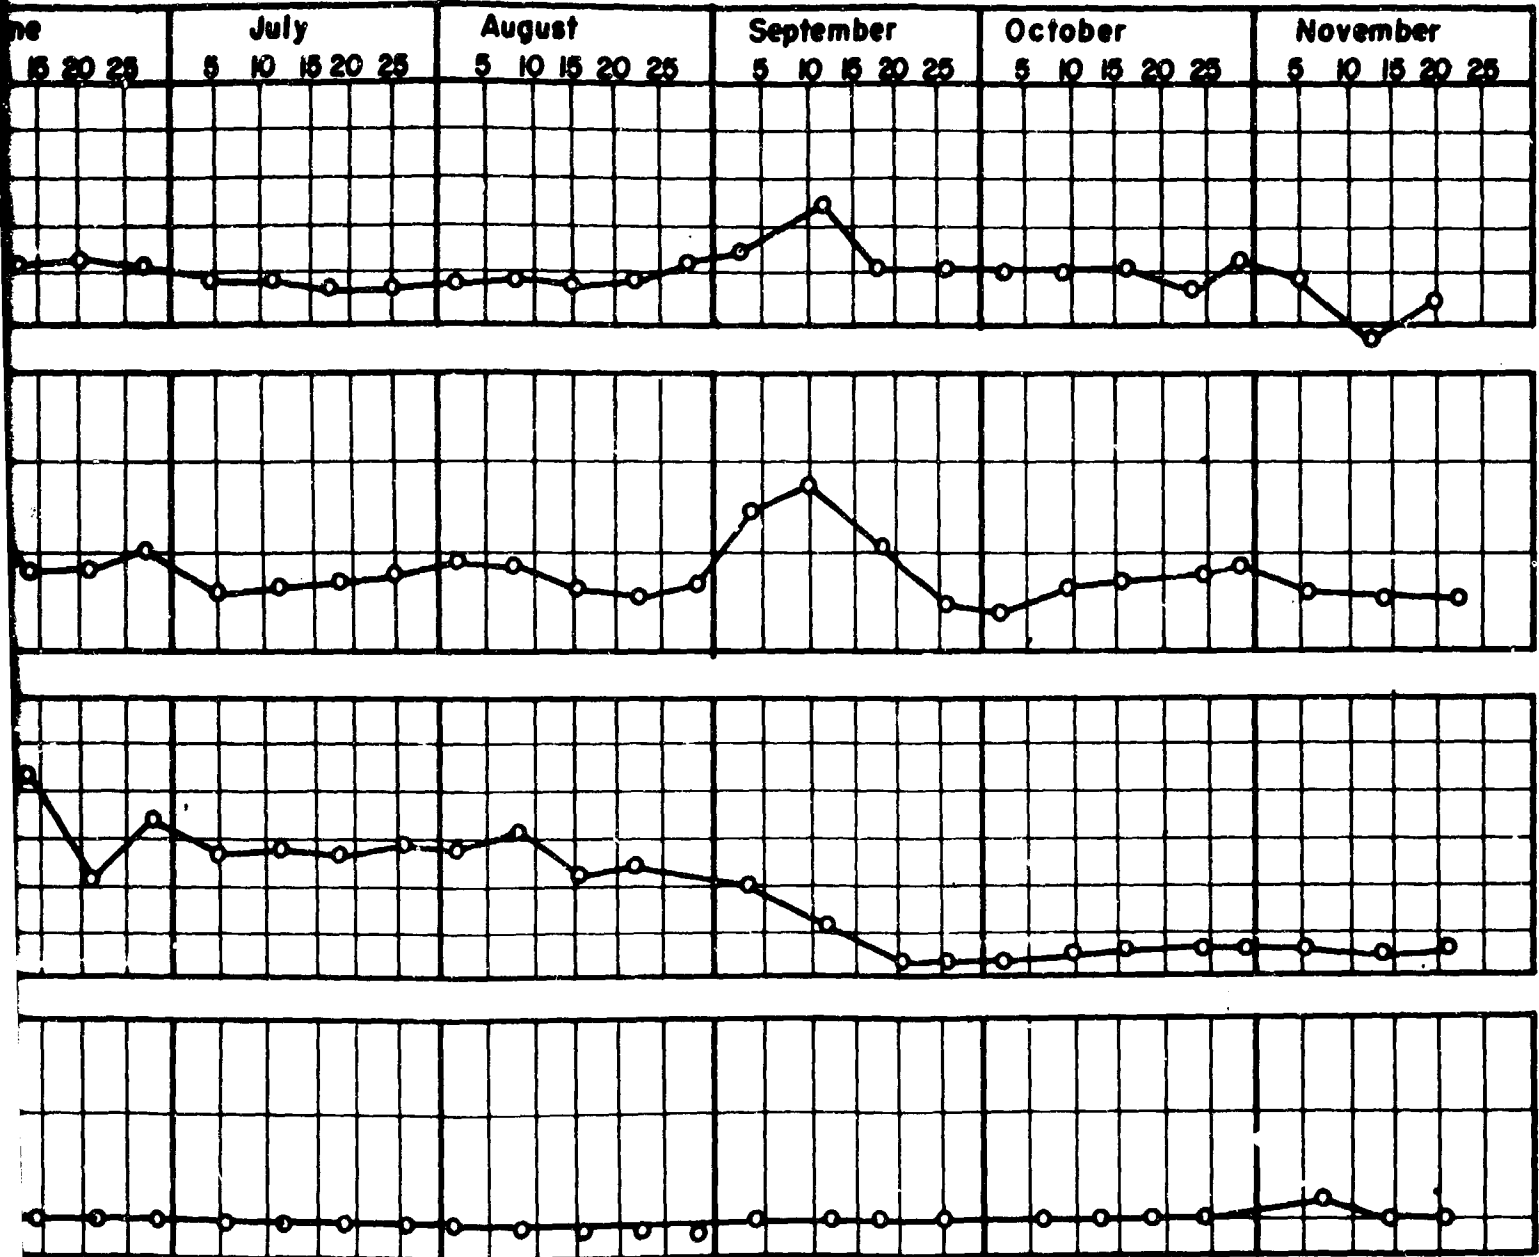
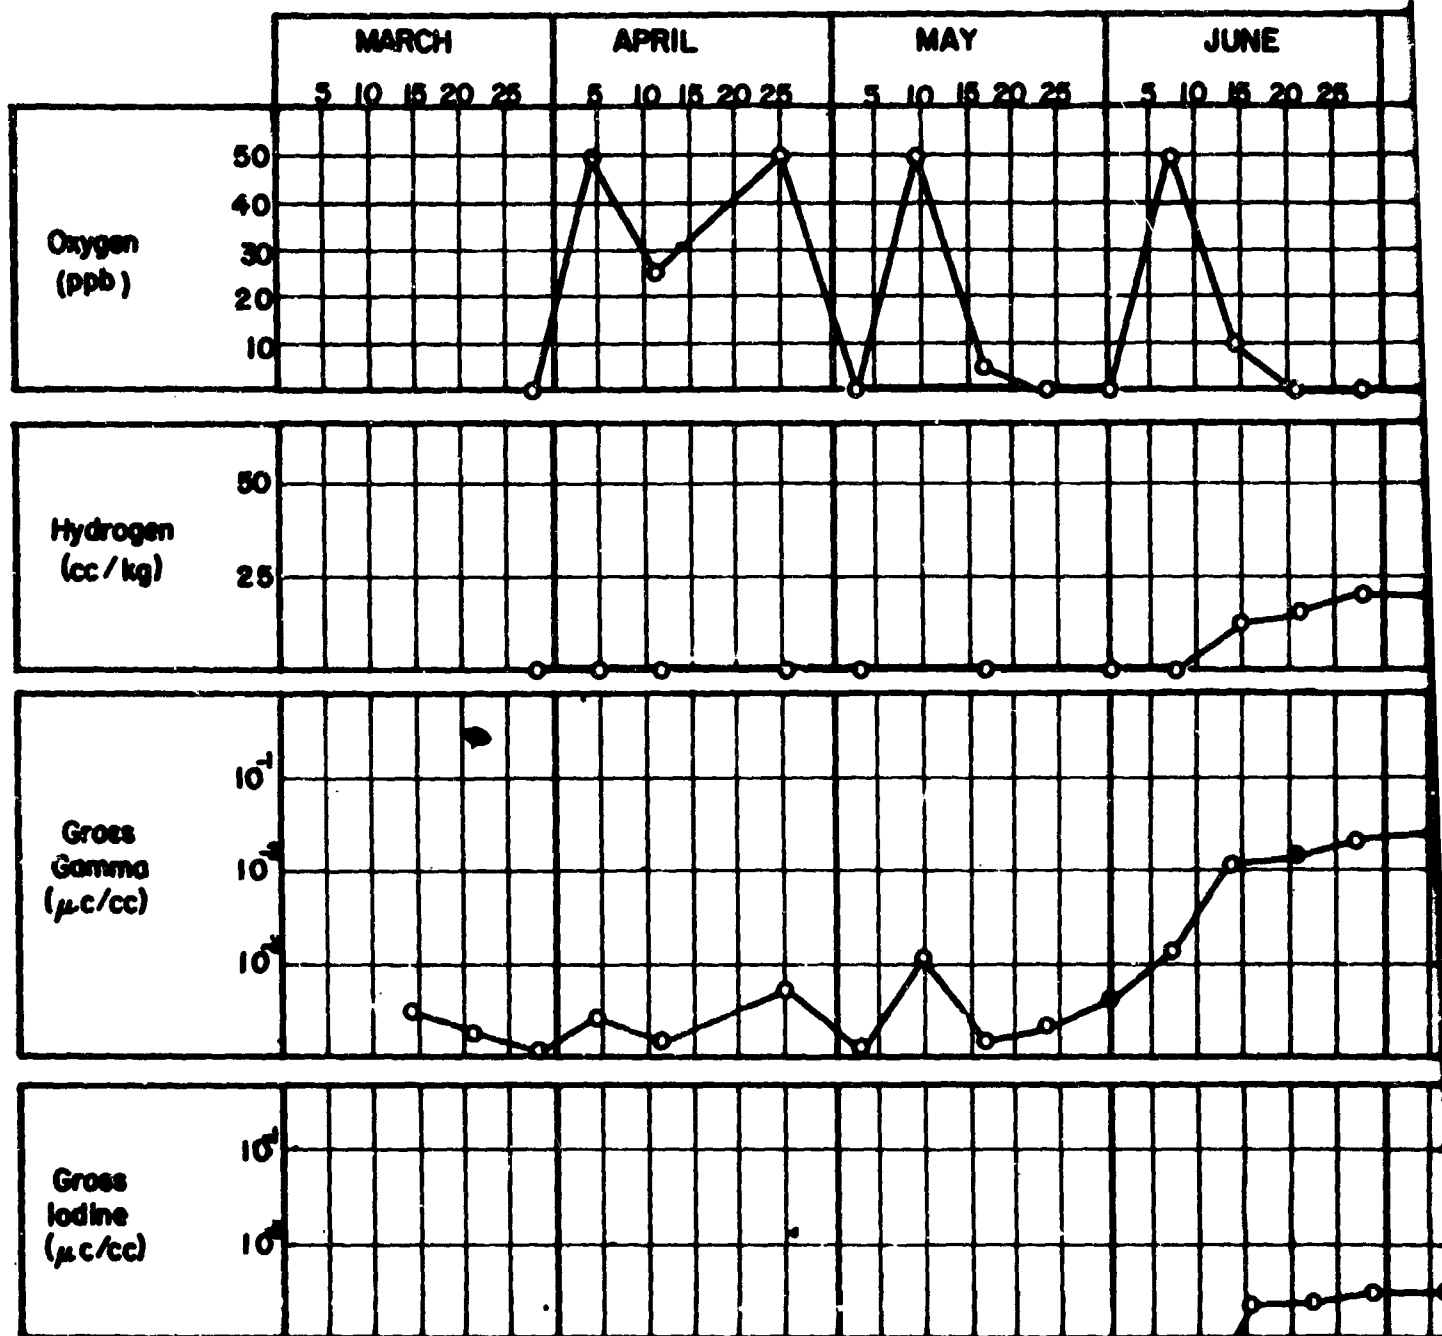
FIGURE 2a. PRIMARY COOLANT CHEMISTRY

The gross activity level in the coolant increased steadily from mid-June to late August, 1964, where it appeared to level off at about 10^{-1} $\mu\text{c/ml}$ as shown in Figure 2. ⁽⁷⁾ A decrease to about 4×10^{-2} $\mu\text{c/ml}$ was observed in September, but during October the activity again rose to a high of 4.5×10^{-1} $\mu\text{c/ml}$ before shutdown in November. During the periods of high activity the gross activity was characterized by a predominance of fission products, rather than the usual activation and corrosion products.

The gross iodine activity levels rose from 4×10^{-3} to 10^{-2} $\mu\text{c/ml}$ and appeared to level off in July. In August, however, the activity increased to 10^{-1} $\mu\text{c/ml}$ and again appeared to level off. The iodine activity level decreased during September to a low of 4.5×10^{-3} before climbing to about 2.5×10^{-1} $\mu\text{c/ml}$ in October. The decrease in gross iodine after shutdown in November was very slow indicating a considerable inventory of I-131 in the system. Only intermittent purification flow was used during the shutdown; as a consequence, the reduction in coolant activity was largely the result of radioactive decay, rather than removal by the demineralizer.

The reason for the decrease in activity in September, 1964, was not readily discernible but may have been due to obtaining a poor sample as a result of a partially plugged line. Site personnel reported release of some unidentified material from the sample line early in October. ⁽⁶⁾

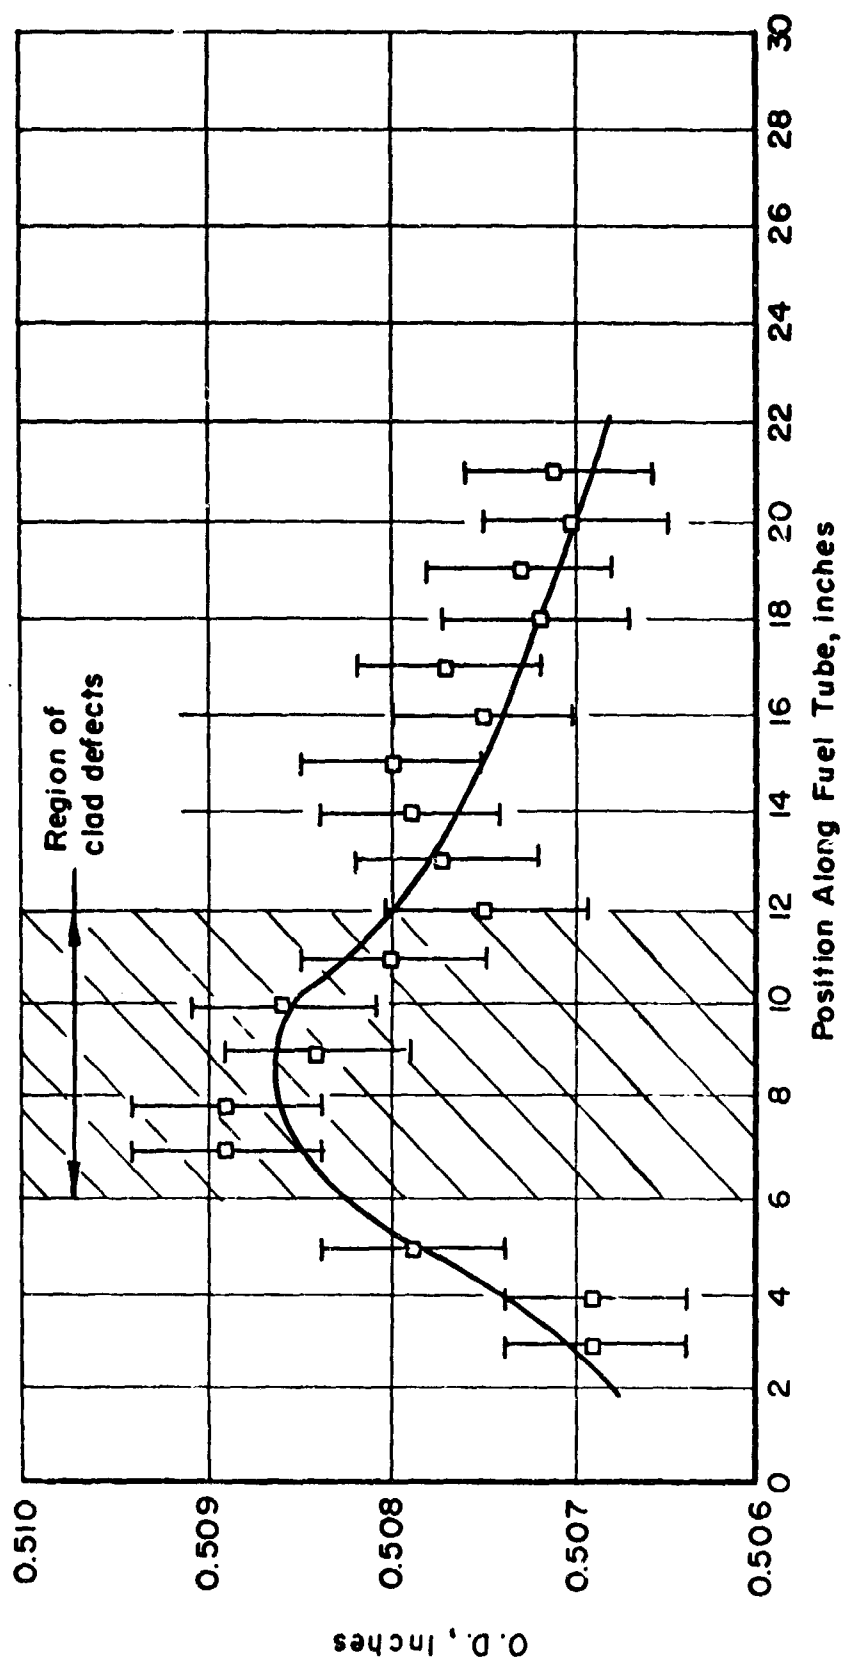
FIGURE 11. AVERAGE O.D. FOR FUEL TUBE 12-46

In an attempt to determine relative swelling behavior along fuel tube lengths, the outer diameters of six fuel tubes were measured at every inch of fuel length. The results of these measurements are tabulated in Table 1. Diameters of fuel tube 12-46 are plotted as a function of longitudinal position along the tube in Figure 11. No attempt was made to descale the fuel tubes before the diameters were measured and some scatter was introduced to the data because of the nonuniform scale on the tube surfaces. As mentioned previously, the black scale had flaked off the high-performance regions of the fuel tubes. Average measured diameters ranged from 0.506 (close to nominal as-fabricated diameter) at a position 10 in. from the top of the fuel to 0.509 in. at a position 22 in. from the top of the fuel. The trend toward larger diameters in the high-performance region is shown in Figure 11. The regions of large diameter also corresponded to defected regions suggesting that cracking of the clad was related to strain.

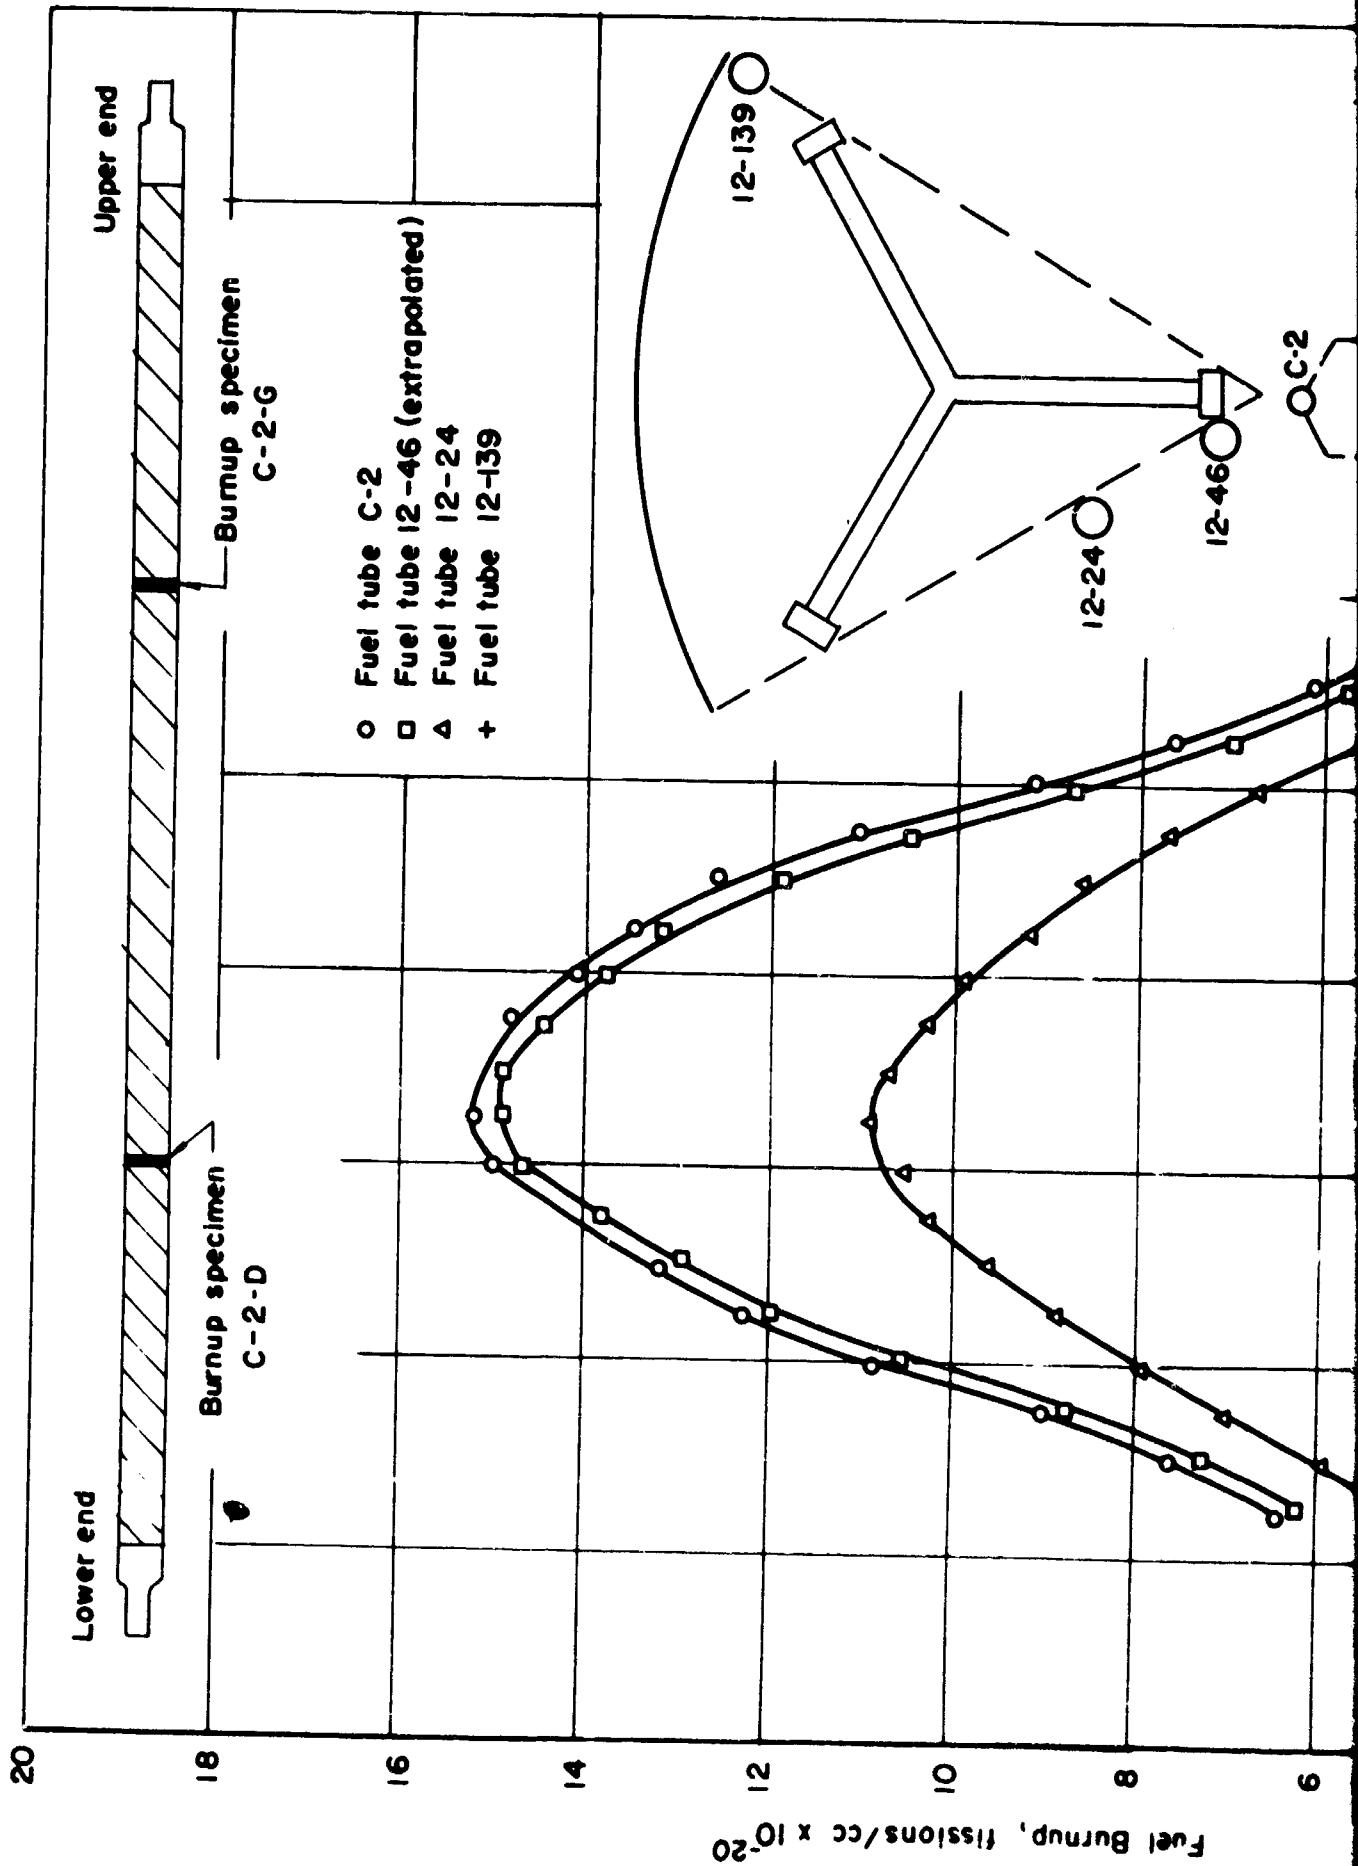
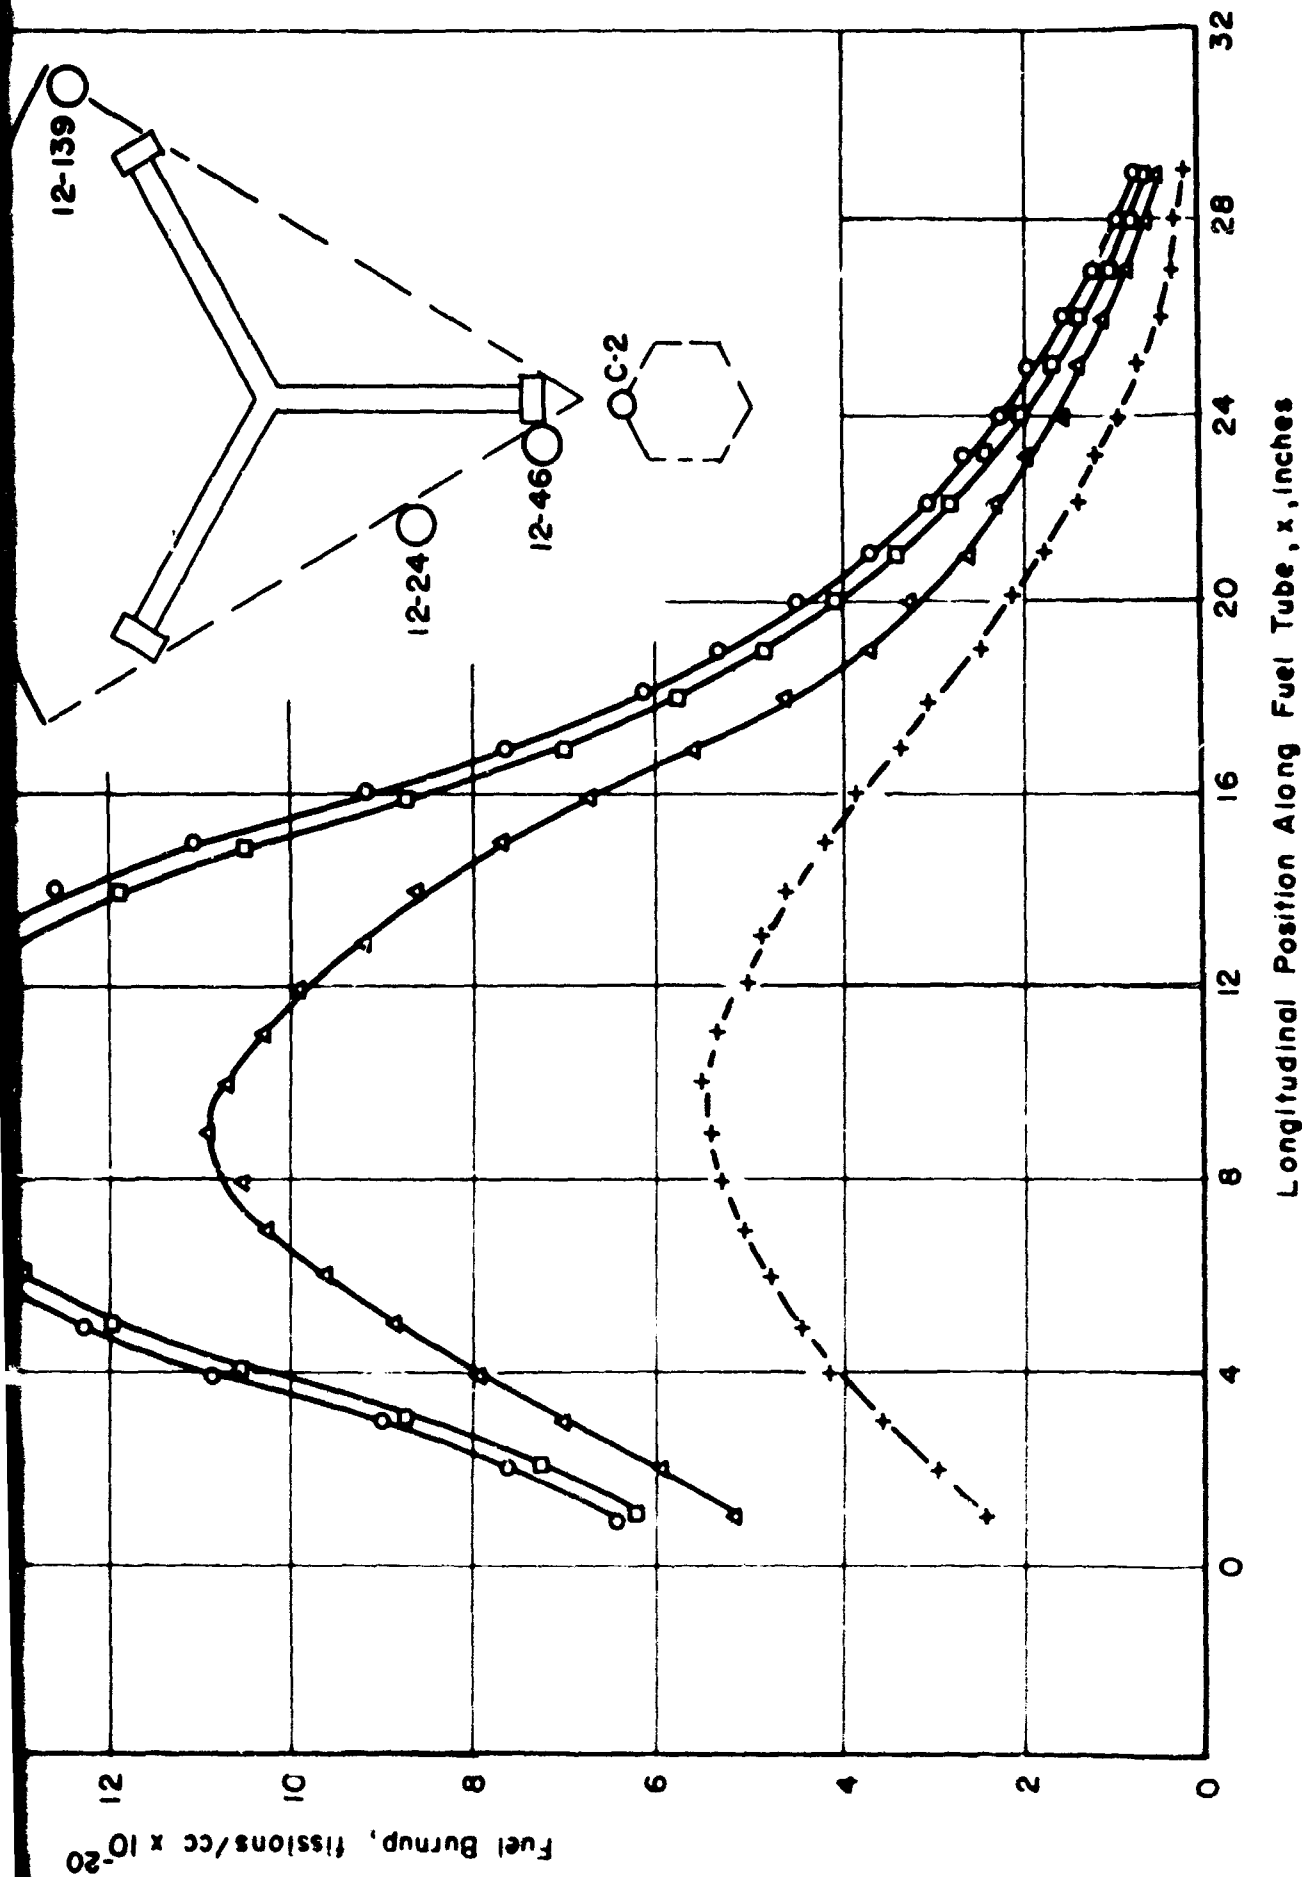
FIGURE 12. FUEL TUBE BURNUP AS A FUNCTION OF LONGITUDINAL POSITION

Burnup profile data shown in Figure 12 for fuel tube 12-46 were obtained by interpolation of burnup profile data from neighboring fuel tubes C-2 and 12-24, since fuel tube 12-46 was not gamma scanned before it was sectioned.

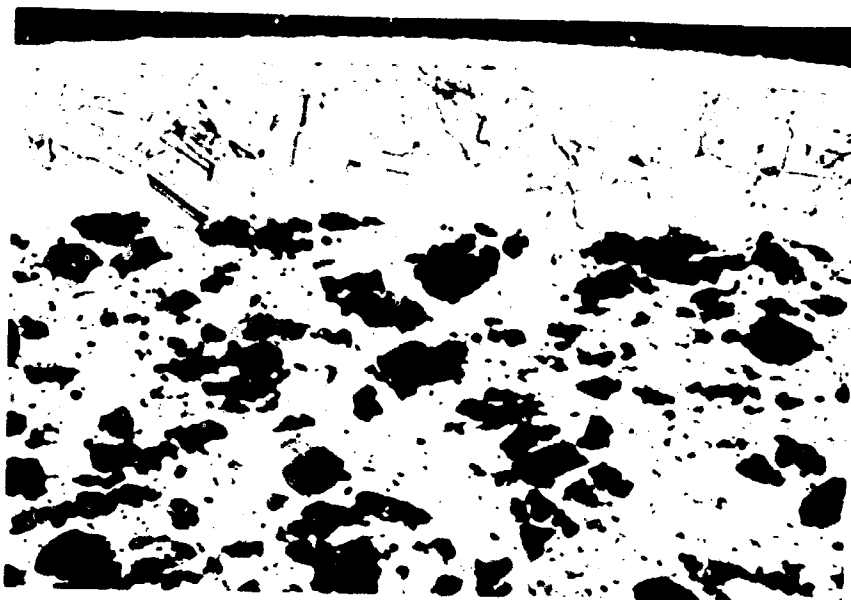
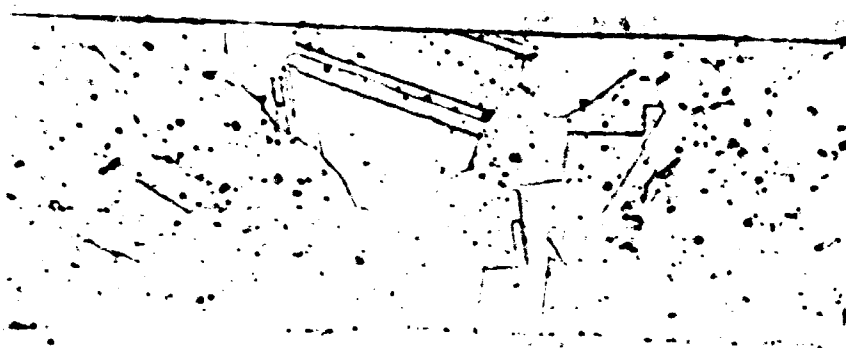
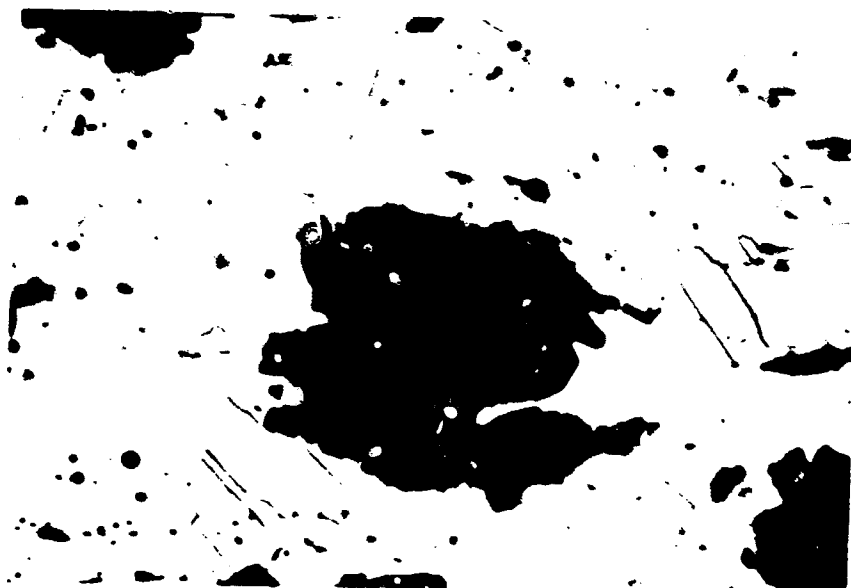
FIGURE 13. AS-
FABRICATED PM-3A
FUEL TUBE METAL-
LOGRAPHY FUEL
TUBE X3BK

As-Fabricated Fuel Tube. Micrographs depicting the microstructure of an as-fabricated PM-3A fuel tube are shown in Figure 13. Examination of the microstructure indicated that the fuel dispersion was metallurgically bonded to the cladding. It was noted that the grain size and orientation was such that from 3 to 6 grains spanned the clad thickness (about 7 mils).

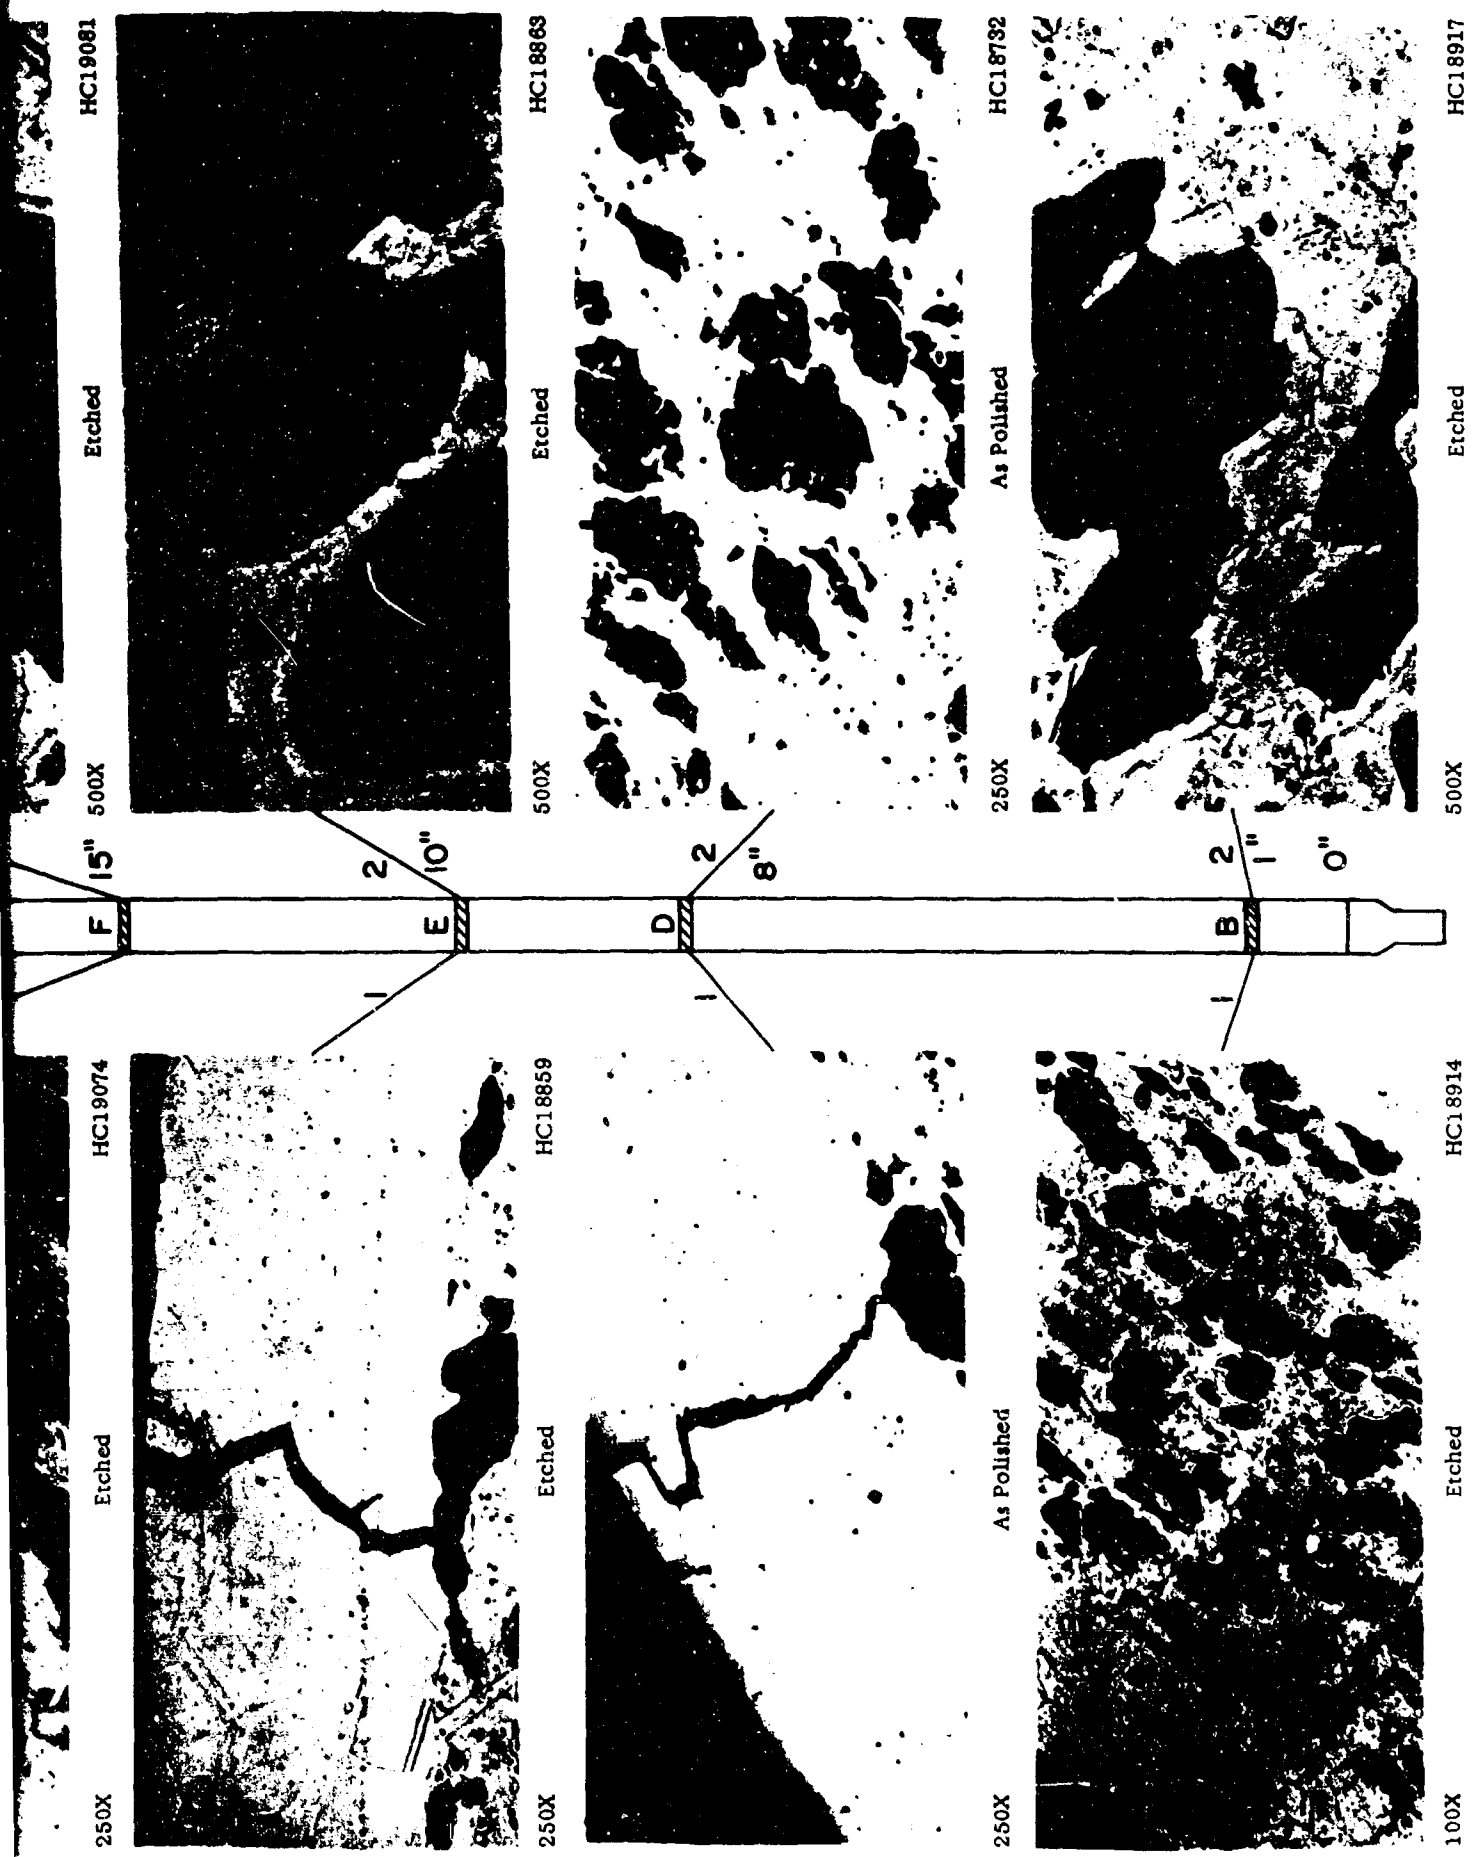
FIGURE 14. MICROSTRUCTURES OBSERVED AT SEVERAL POSITIONS IN FUEL TUBE 12-46

Figure 14 shows results of clad and fuel matrix metallography, respectively, for fuel tube 12-46. The following comments can be made concerning the six metallographic specimens at the indicated positions for fuel tube 12-46.

1. Position B: No cracks were found in the clad at this position on fuel element 12-46. Figure 14B-1 shows a typical micrograph of the clad and clad-fuel matrix interface. No damage was noted to clad or clad-fuel interface. Depending on size and orientation of grains, between 3 to 6 grains spanned the cladding thickness. Figure 14B-2 shows a typical micrograph of a UO_2 particle. Some porosity was observed in the UO_2 particles at this location.

2. Positions D and E: Figures 14D-1 and 14E-1 show typical micrographs of the cladding and clad-meat interface at the D and E positions of fuel element 12-46. Discussions of D and E positions are combined because of similar results. The following comments apply to both positions on the fuel element:

- a. About 30 cracks were detected around the periphery of the outer clad.
- b. Many cracks (about 1/3) were double at the outer edge and combined into a single crack at some point within the clad and continued as a single crack which terminated at a fuel particle.

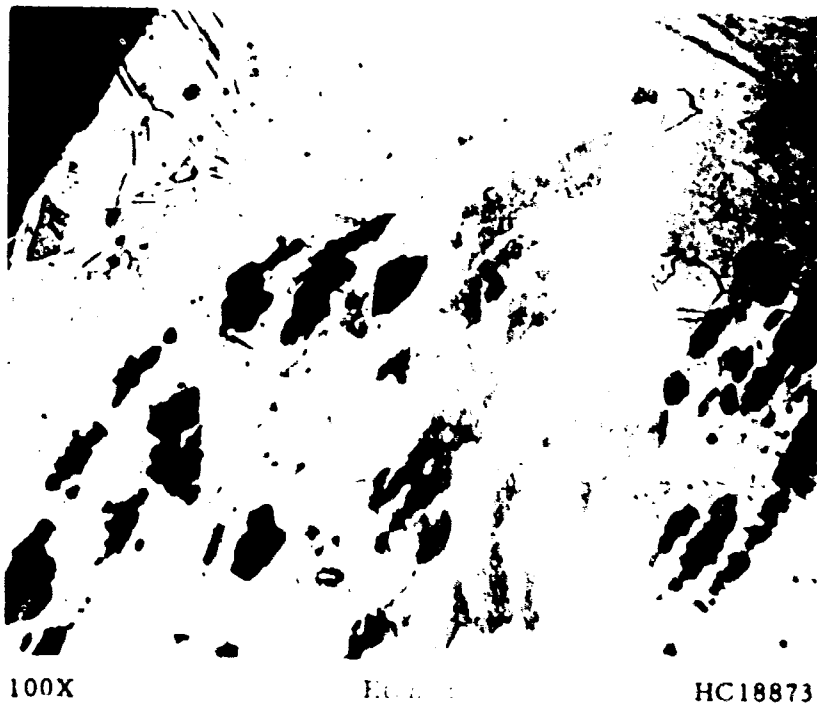
Figures 18a and 18b represent typical microstructures of fuel tube 12-90. Figure 18a shows a crack which extends into the outer clad approximately three mils. This was the only crack found on this specimen which was taken from the high performance region of fuel tube 12-90. Figure 18b shows the condition of the dispersion fuel in the vicinity of a UO_2 particle. An indication of second phase material was also observed in the UO_2 particle. Identification of the second phase was not attempted, since it seemed unlikely that the material contributed to clad failure. The 6-micron-thick band around the fuel particle probably reflects the fission product recoil range, rather than interaction between UO_2 and stainless steel.

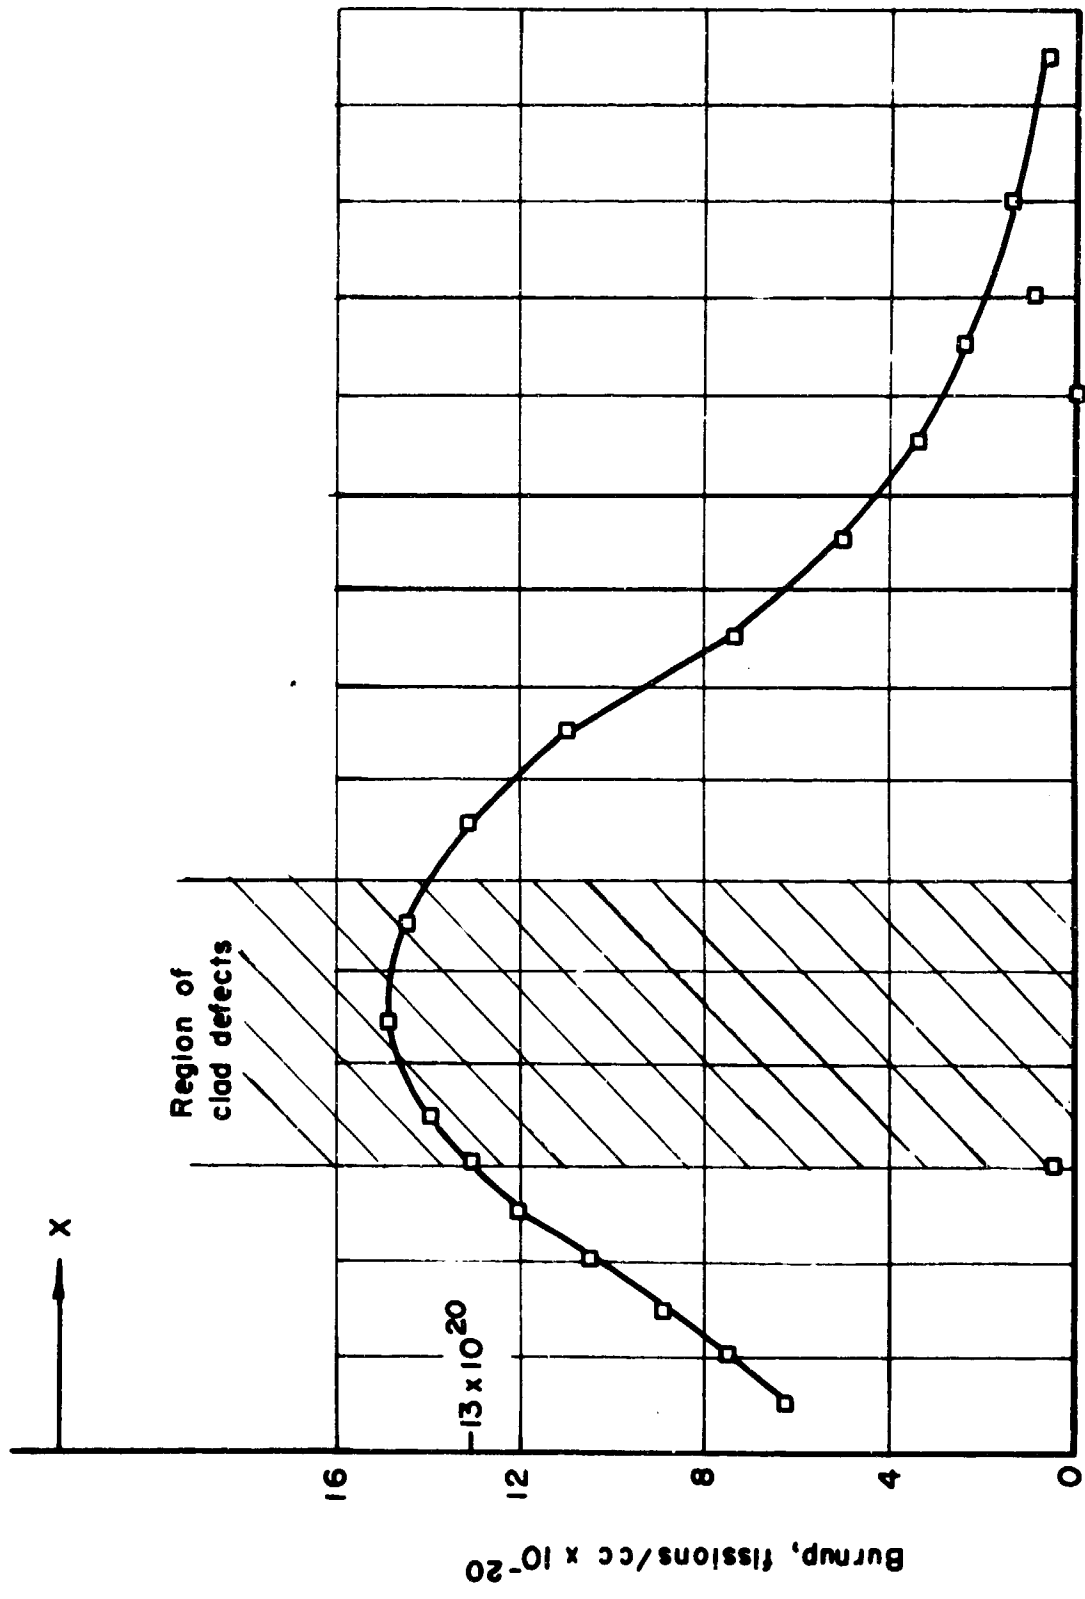
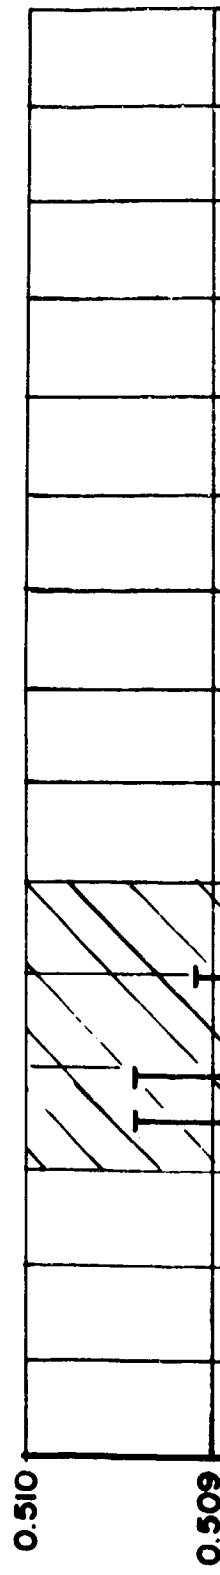
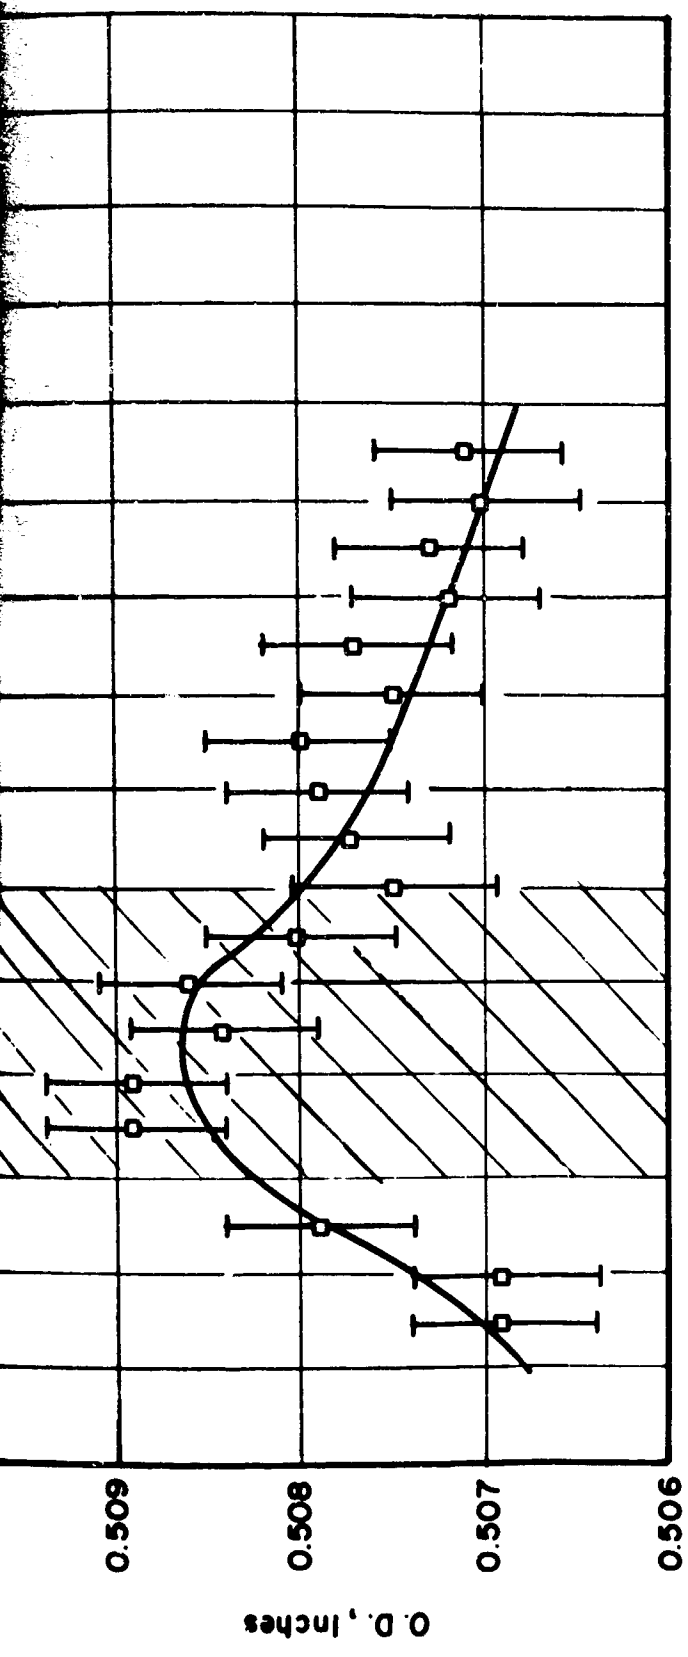
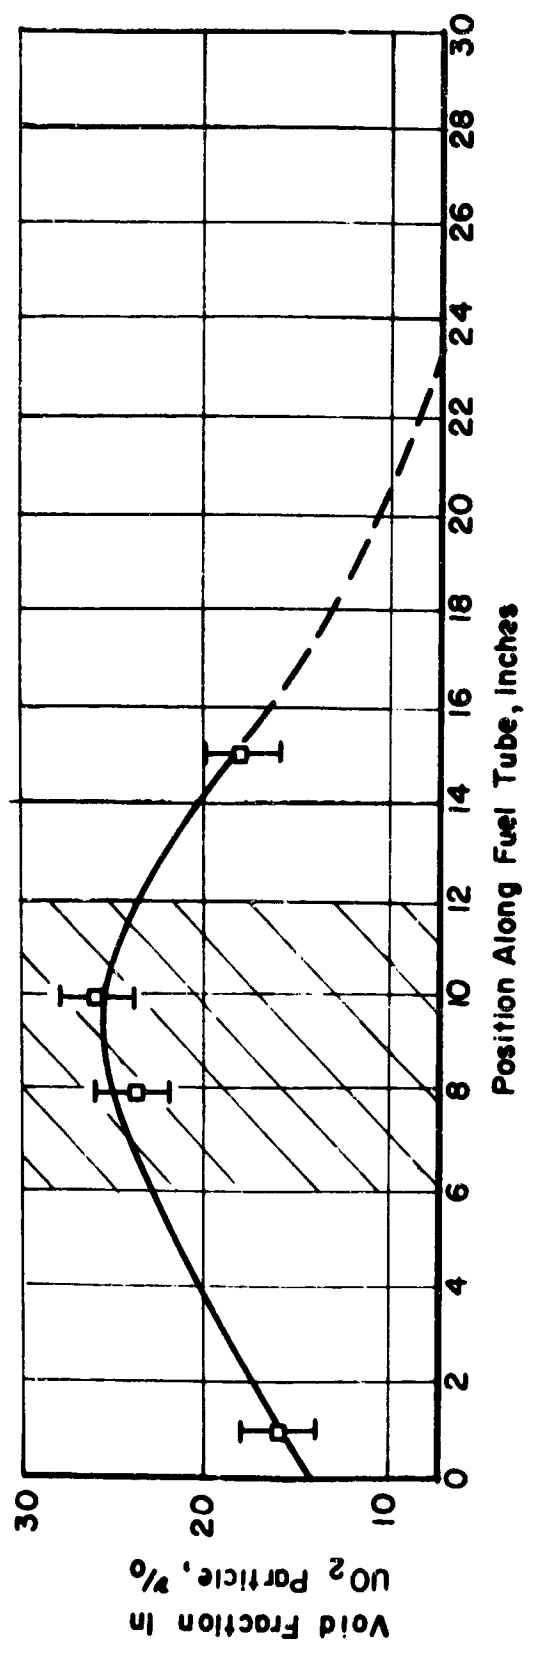
FIGURE 25 RELATIONSHIP OF FUEL BURNUP, FUEL PIN SWELLING AND VOID FRACTION IN UO_2 PARTICLES TO FORMATION OF CLAD DEFECTS IN FUEL TUBE 12-46

The results of the examination indicated that the fission products leaked through numerous intergranular cracks in the outer clads of fuel tubes from the high-performance region of the core (toward the core center). These cracks started on the outer surface of the clad and generally terminated at UO_2 particles near the fuel dispersion-clad interface. All the cracks were longitudinal, suggesting their association with hoop stresses. As shown in Figure 25, the cracks occurred only in high-performance regions of the fuel tubes where burnups exceeded about 13×10^{20} fissions/cm³ and where fuel swelling produced strains of about one percent in the clad.
